DEPARTMENT OF TRANSPORTATION**DIVISION OF ENGINEERING SERVICES**

Quality Assurance and Source Inspection

Contract #: 04-0120F4Cty: SF/ALA Rte: 80 PM: 13.2/13.9File #: 1.28**WELDING INSPECTION REPORT****Resident Engineer:**Pursell, Gary**Address:** 333 Burma Road**City:** Oakland, CA 94607**Report No:** WIR-012636**Date Inspected:** 12-Mar-2010**Project Name:** SAS Superstructure**OSM Arrival Time:** 630**Prime Contractor:** American Bridge/Fluor Enterprises, a JV**OSM Departure Time:** 1500**Contractor:** American Bridge/Fluor Enterprises, a JV**Location:** Job Site

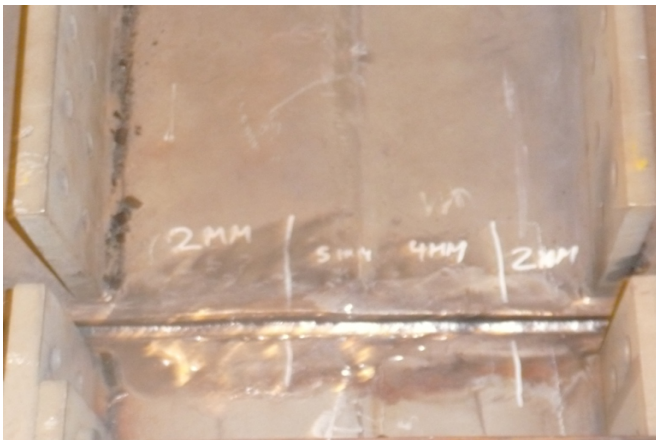
2E/3E-D

Upon the arrival of the QA Inspector it was observed the above identified weld joint was previously started with flux cored arc welding (FCAW) tack welds and submerged arc welding root/fill/cover passes. Upon the arrival of the QA Inspector it was noted the majority of the weld joint was completed with a cover pass from the center of the joint outward. The QA Inspector randomly observed the only remaining weld to be completed were at the ends of the weld joint, where the SAW machines could not reach. It was noted the ABF welder were utilizing FCAW at the ends of the welds to complete the welding. The QA Inspector noted approximately 200cm at each end of the weld joints were in process. The QA Inspector randomly observed the minimum required preheat of 150°F was achieved utilizing induction heat blankets prior to the ABF welder performing welding. The QA Inspector verified the minimum required preheat utilizing a temperature indicating marker. The QA Inspector observed the Smith Emery (SE) Quality Control (QC) Inspector Bnifacio Daquinag was present at the above identified location to monitor and observed the in process welding. The QA Inspector randomly observed the FCAW parameters being utilized by the ABF welder James Zhen and they were 279 Amps, 23.6 Volts and a travel speed of 240mm/min. The QA Inspector randomly observed the FCAW parameters being utilized by the ABF welder Song Tao Huang and they were 260 Amps, 23.6 Volts and a travel speed of 265mm/min. The QA Inspector noted the FCAW parameters were consistent with the approved parameters of the ABF-WPS-D1.5-3040B-1. The QA Inspector randomly observed rain water had entered the weld zone while the material was approximately 255°F. The QA

Inspector noted steam began forming in the weld joint in the area of the in process weld. The QA Inspector noted the water did come in contact with the welding arc, rather in contact with the previously welded fill pass (pictured below). The QA Inspector observed the ABF welding Foreman Jordan Hazelaar shut down the welding operation for the remainder of the shift, due to weather conditions. The QA Inspector randomly observed and noted the water intrusion was corrected with plastic tarps. No other water issues were observed on the QA Inspectors shift.
